Service Bulletin: EMI Filter Too Close to Power Switch Bracket	
Prepared by: Maxwell Anderson	Date Prepared: 6/6/2022	Models Affected: T101-07 (HTM1382-01/HTM1376-01)

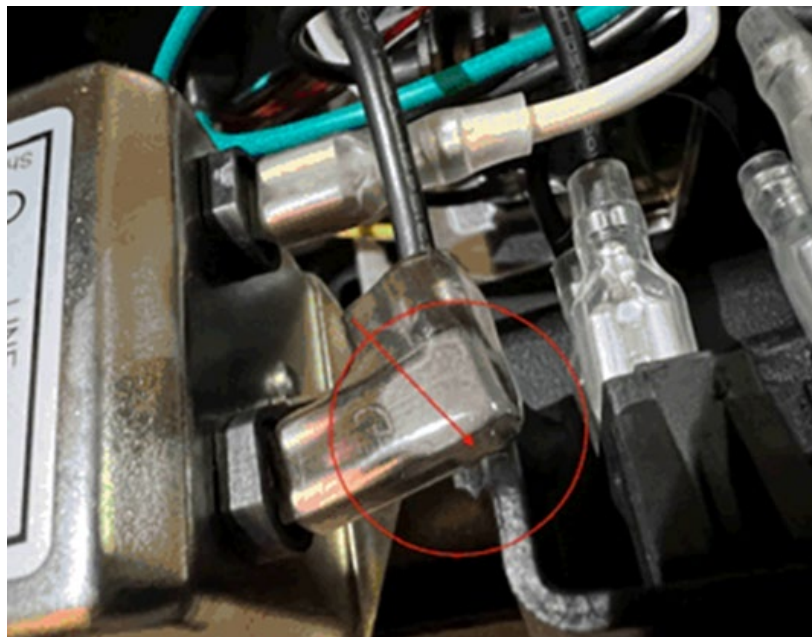
1. Turn the unit off and disconnect it from the outlet.
2. Remove the motor cover.
3. Inspect the power switch bracket and EMI filter to determine if the EMI filter wire is rubbing against the power switch bracket.

4. Disconnect and completely remove the EMI wire that rubs against the power bracket.
